Understanding and Reducing Impacts of Storm water Culvert Rehabilitation Technologies

June 21, 2018, LaPorte, IN

Kyungyeon Ra, Mahboobeh Teimouri,
Dr. John Howarter, Dr. Chad Jafvert, Dr.
Andrew Whelton, Purdue University

Pooled Fund Project - Contaminant Release from Storm Water Culvert Rehabilitation Technologies: Understanding Implications to the Environment and Long-Term Material Integrity

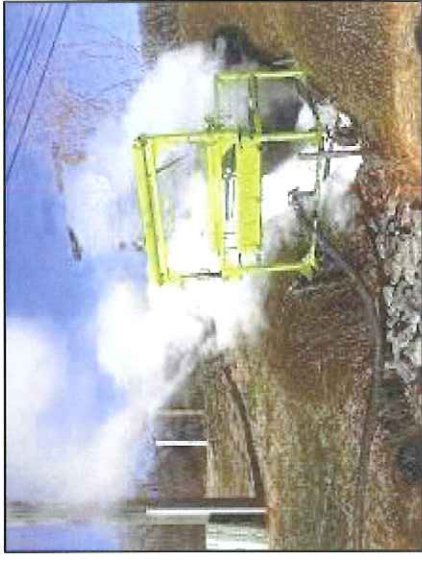
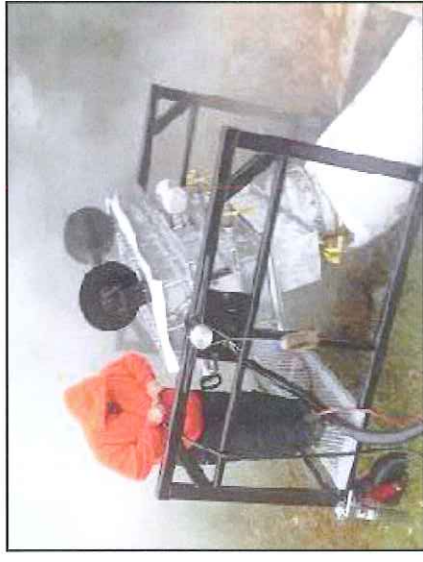
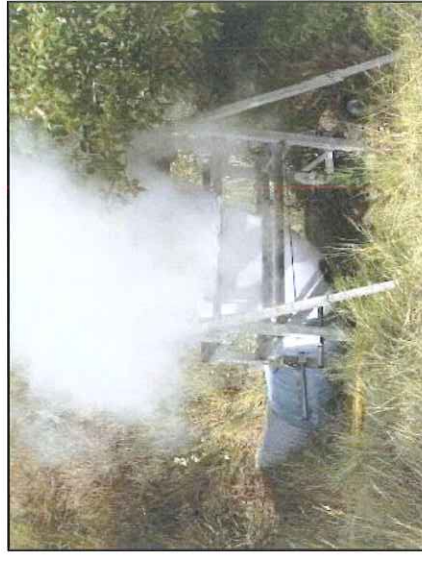
A new plastic pipe is **Chemically Manufactured** inside an existing damaged pipe

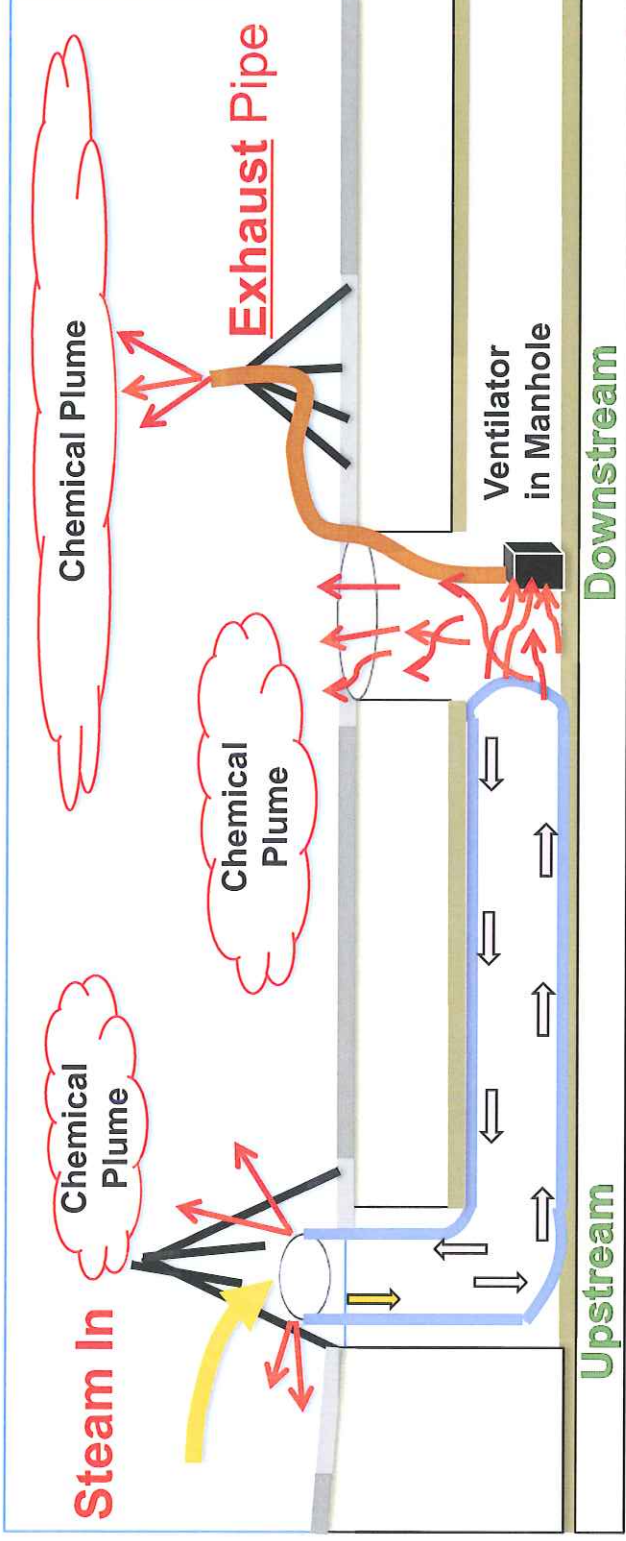
Example of steam CIPP for storm sewer

1. Curing facilitated by hot water, steam or UV light
2. Various resins (Styrene vs. Nonstyrene based)
3. Different contractors that manufacture similar “types” of CIPP can have different setups and processes
4. Styrene is only one of many chemicals used
5. *New chemicals can be created during CIPP manufacture*

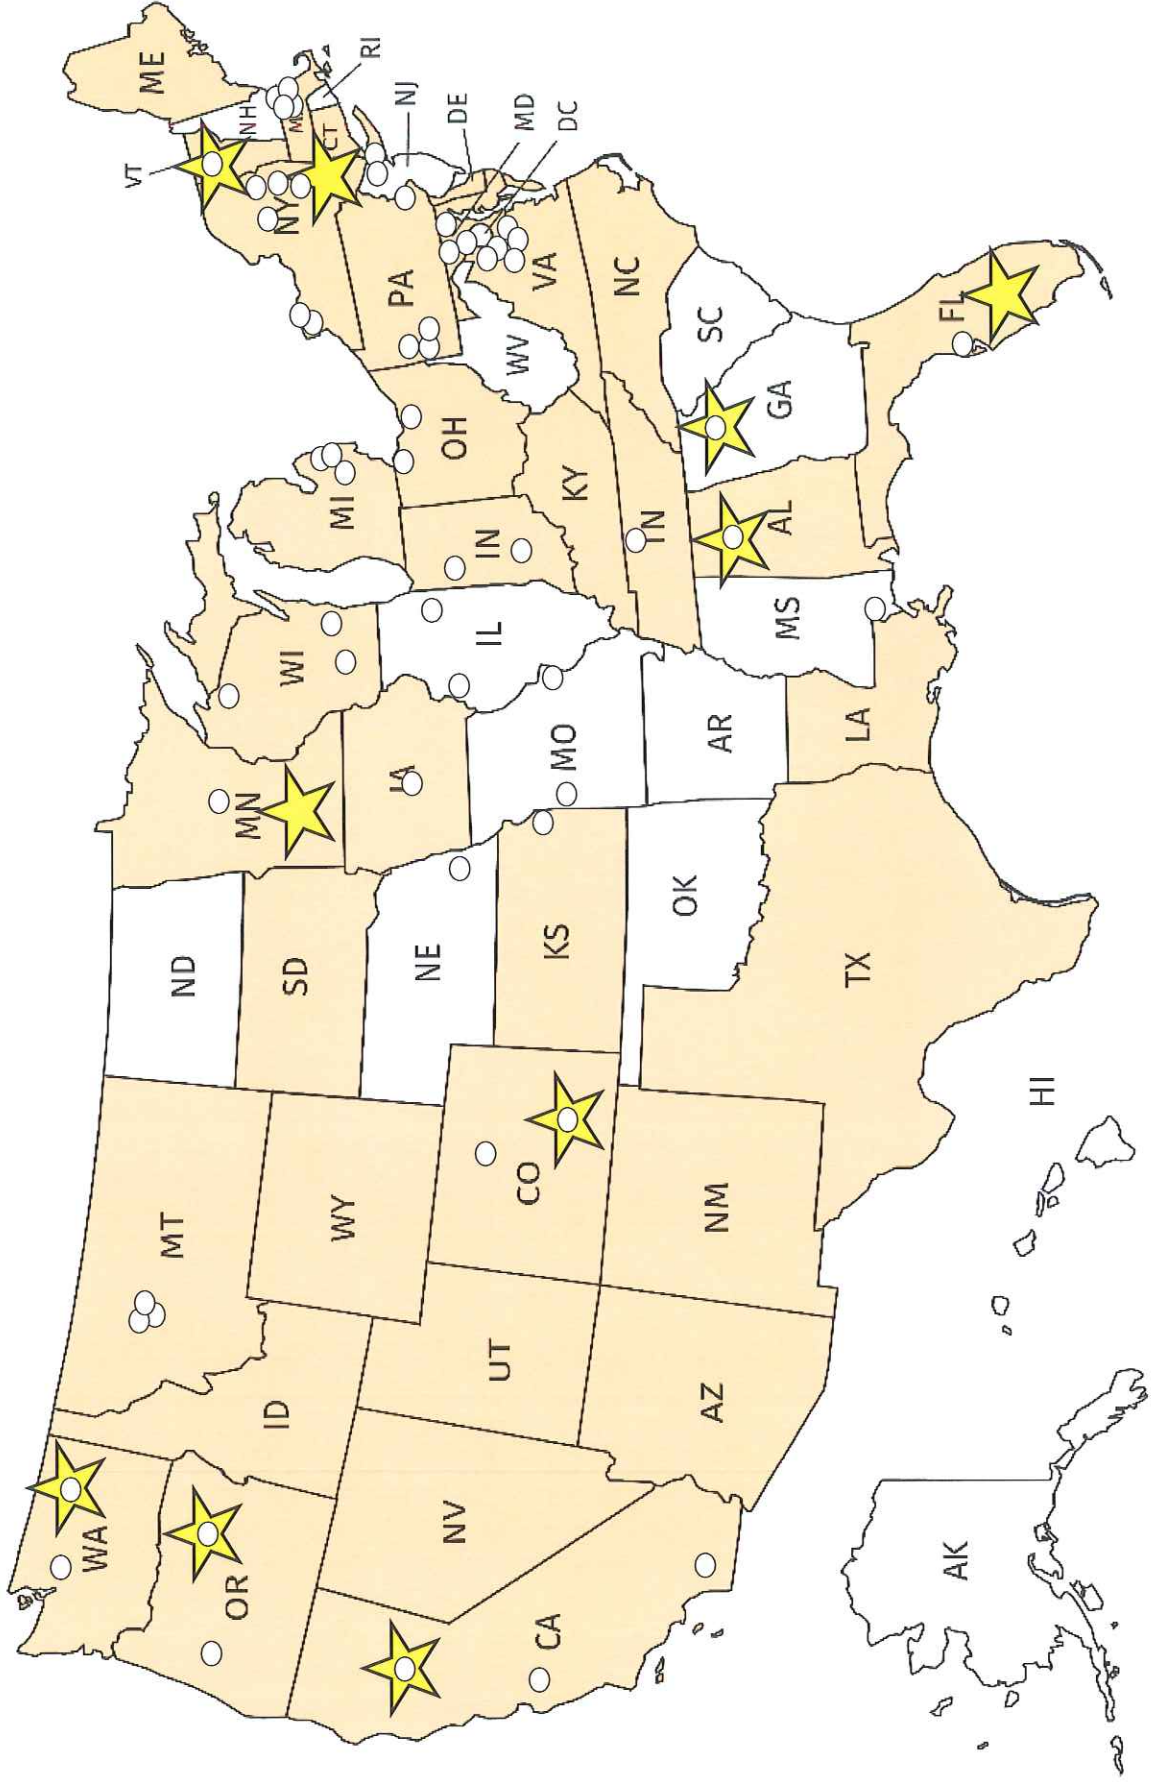
10 water contamination incidents were found in the US

+2 in Canada

+1 undisclosed location

Of the 13 water contamination incidents...

- **Alabama (2010):** National Response Center
 - 70,000 gallons of CIPP wastewater released to a dry creek bed
 - Styrene concentration in the creek water (143 mg/L), contaminated nearby drinking water well (4 mg/L)
- **Colorado (2011):** DOT, Department of Public Health and Environment
 - Chemicals entered surface water and downstream drinking water
 - Maximum styrene level detected in water (18 mg/L) and 14 mg/kg in soil
 - Variety of other chemicals present associated with CIPP
- **Vermont (2013):** DOT, Vermont Department of Environmental Conservation
 - Maximum styrene level in the Creek the day of installation was reported as 5,160 mg/L (Information reported by VTDEC)
 - Styrene level decreased over the two month monitoring period, but other compounds were detected: acetone, 1,2,4-TMB, 1,3,4-TMB, *tert*-butanol

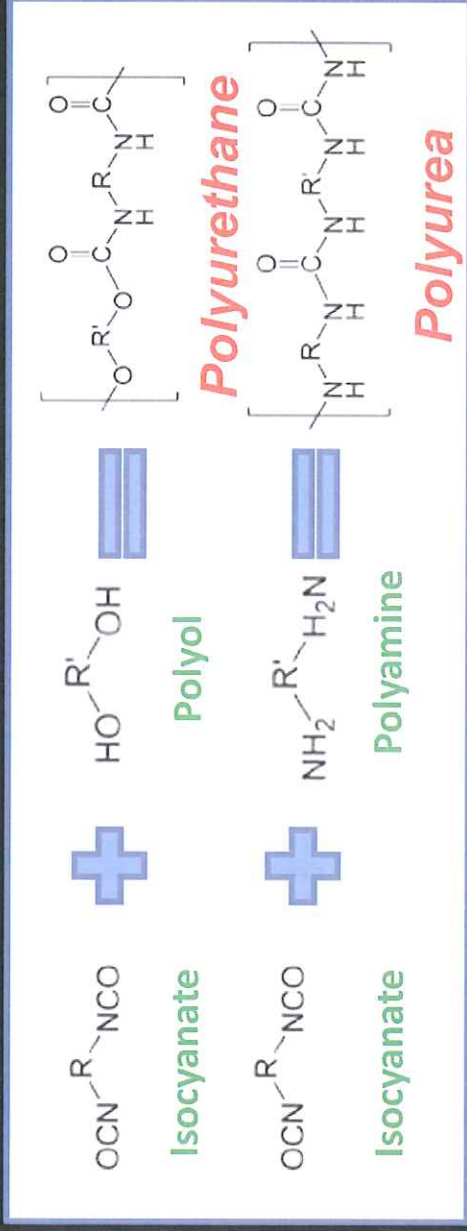
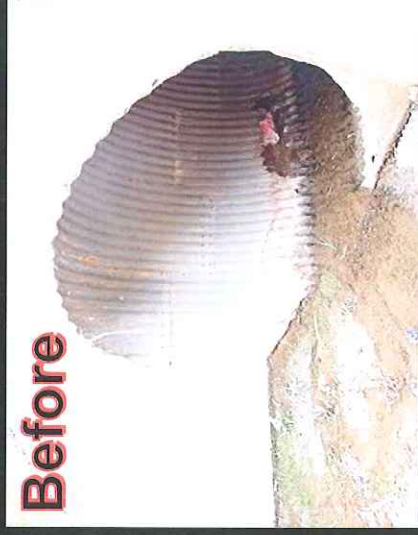
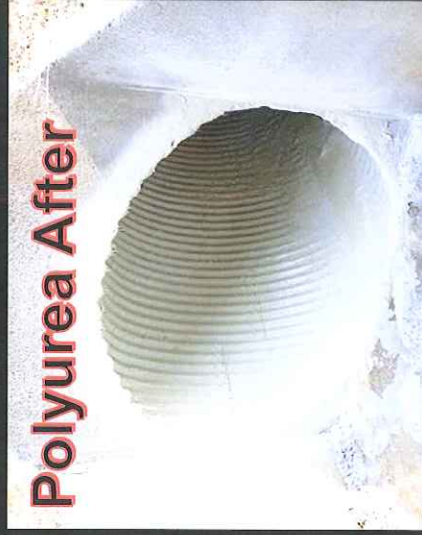
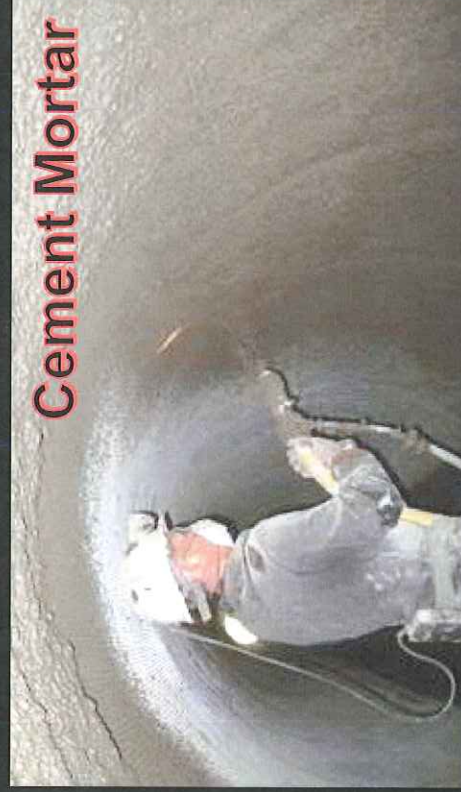
Spray on lining technologies ALSO chemically manufacture the product at the asset repair site
